# U.S ENVIRONMENTAL PROTECTION AGENCY SUBAREA II FOURTH AVENUE AND GAMBELL STREET REMOVAL ACTION INDOOR AIR QUALITY QUESTIONNAIRE AND BUILDING INVENTORY

Preparer's Name: Robert Whittier/Carl Overpeck Date Prepared: 22-February-2014

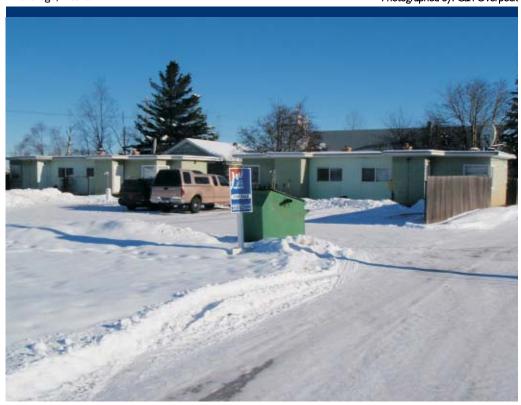
Photo 1 736 East 3rd Avenue North & South Duplexes.

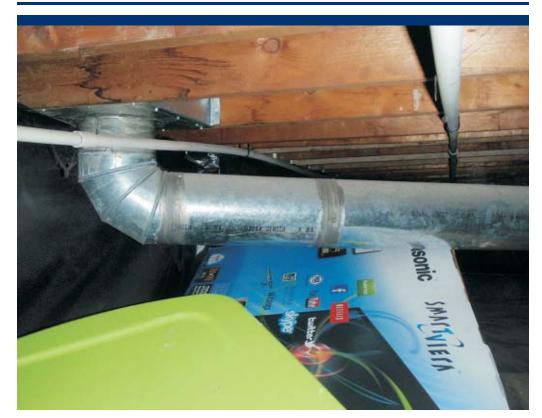
Photo 2 Ductwork in crawl space.

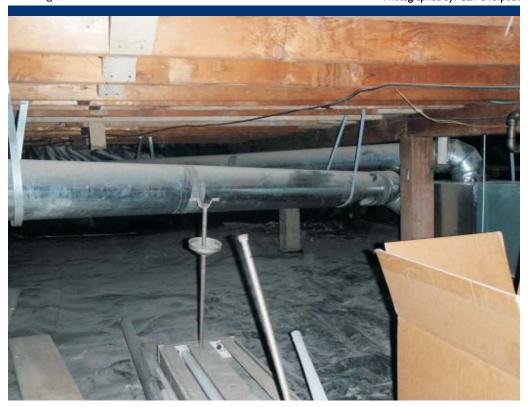
Photo 3 Ductwork in crawl space.

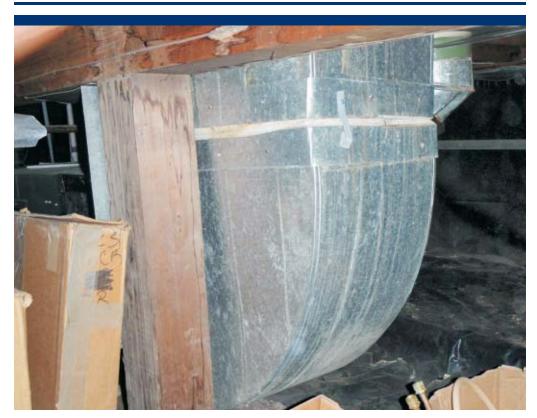
Photo 4 Ductwork in crawl space.

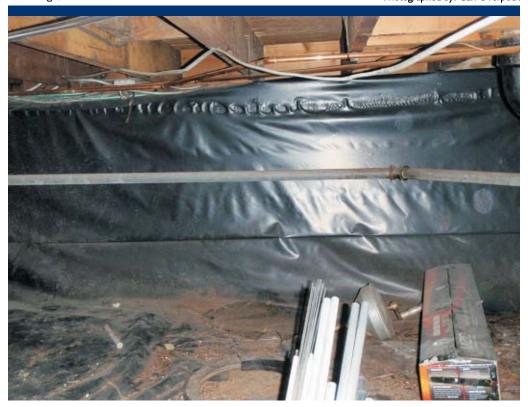
Photo 5 Crawl space.

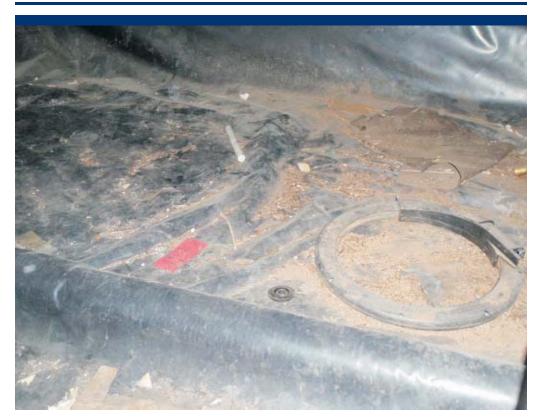
Photo 6 Crawl space liner.

12. DAMAGE TO FIXTURE/FURNISHINGS
Must any fixtures or furnishings such as carpet or tile, be damaged or removed to perform the removal action?
[X] Y [ ] N
If yes, describe: _Old liner to be replaced with new.

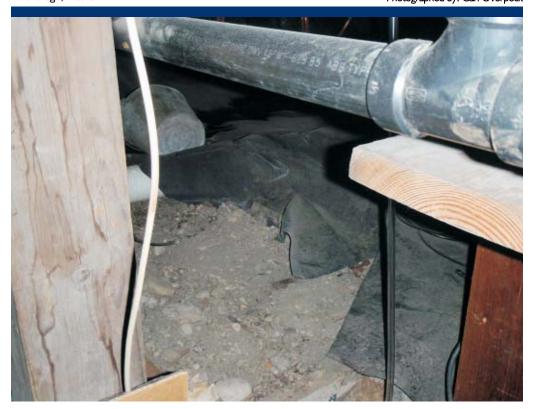
Photo 7 Exposed gravel beneath crawl space liner.

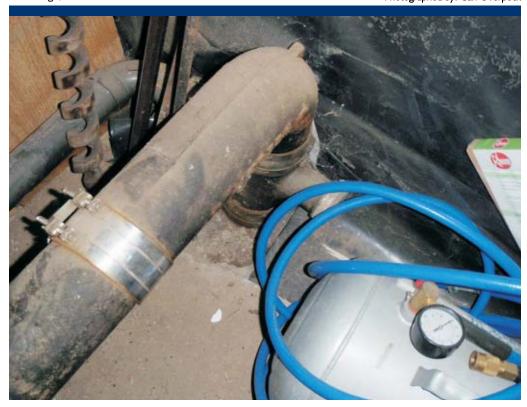
Photo 9 Sewer pipe penetrating slab with exposed gravel.

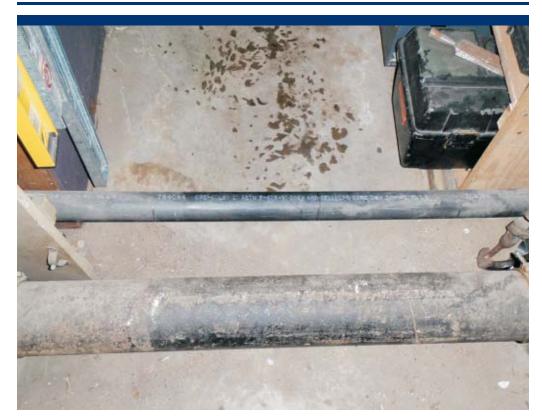
Photo 10 Pipe runs between north room and work shop.

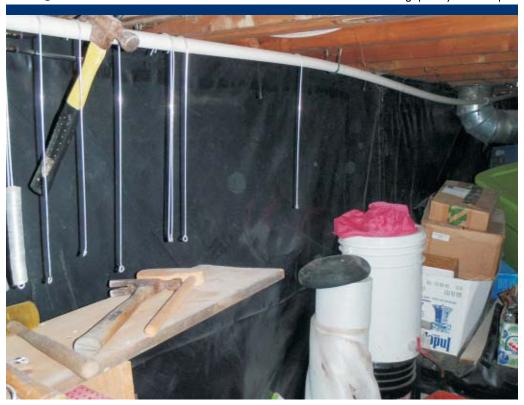
Photo 11 Lined west wall.

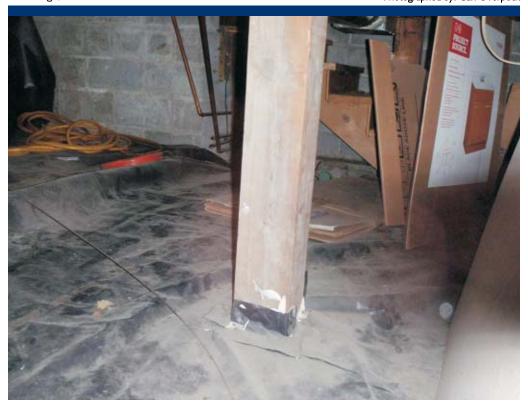
Photo 13 Structural post in crawl space near stairwell.

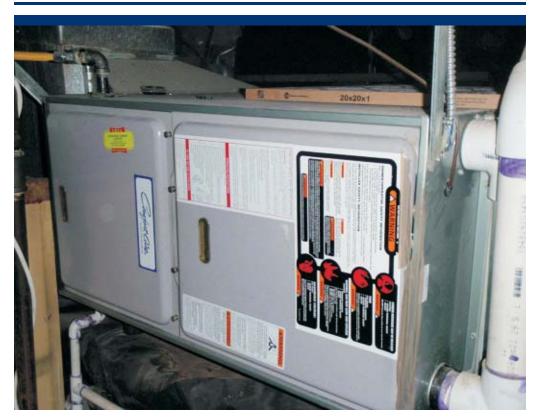
Photo 14 Forced air furnace.

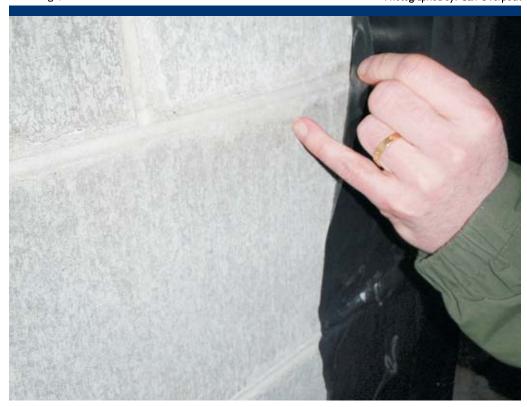
Photo 15 Liner on wall.

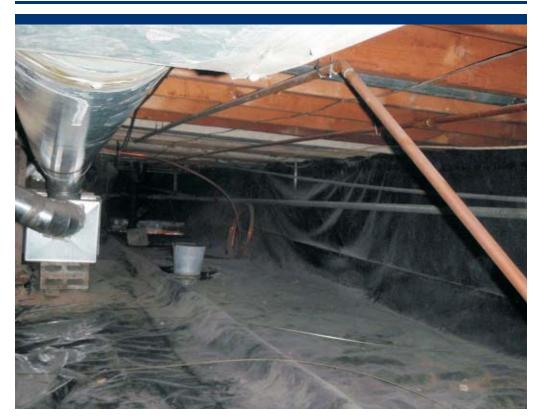
Photo 16 Crawl space.

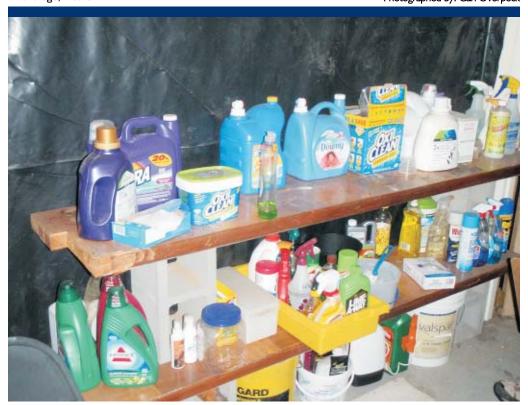
Photo 17 Detergents etc. in laundry room.

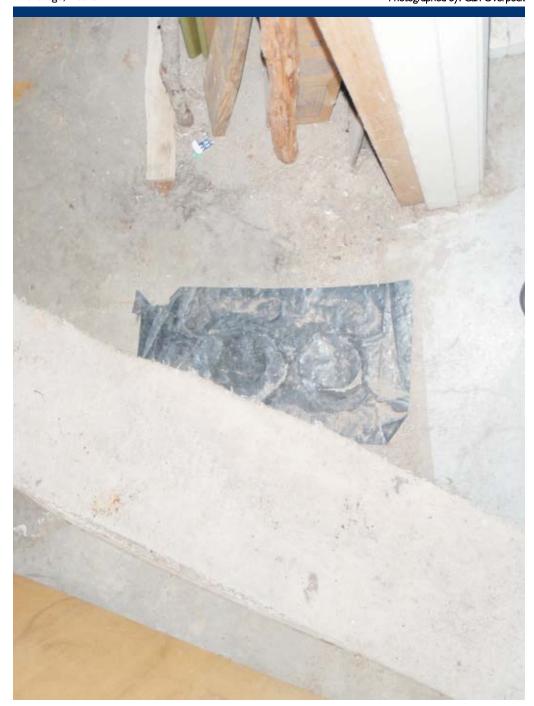
Photo 18 Floor patch between north room and work shop.

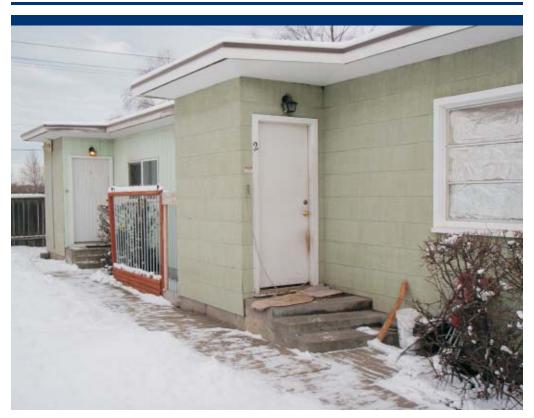
Photo 20 736 East 3rd Avenue North Duplex.
